Extraction of Metric Information from Video Sequences of an Unsuccessfully Controlled Chimneys Demolition

Spremberg Germany, 10th July 1999: in the power plant Schwarze Pumpe, three old chimneys are going to be blown up. The first two fell in the prevented directions; the third ones had to fall onto the other two, but something went wrong and it fell onto the nearby building damaging it extremely.

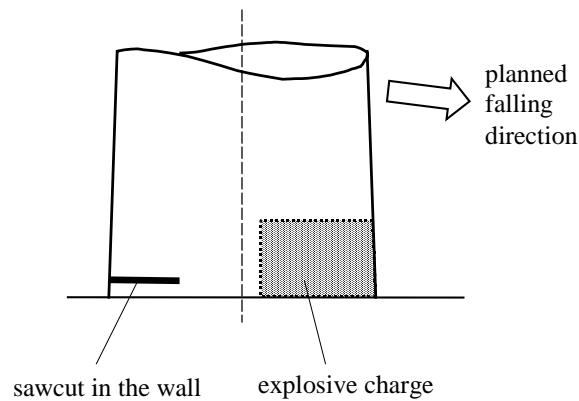
According to this plan, the third blasting can be considered the less problematic one. However it was exactly this chimney which fell uncontrolled. In fact the explosive charge, placed at the base of the chimney, should have destroyed a sector of the wall that lay in the planned falling direction (see figure 2). The reason of the accident could be found in the insulation of sand and mats that was placed at the lower foundation in order to protect the surrounding installations and buildings from exploding parts. In fact, the demolition experts presumed that the layer of insulation was too thick; so that the explosive charge was not powerful enough to destroy only the scheduled piece of the wall, but instead caused a rebound effect which demolished also the opposite area of the chimney wall or even removed the complete foundation wall. Under this assumption the chimney would have dropped in vertical direction first and then after standing for a short time on the irregular lower part of the foundation wall, would have toppled in an accidental direction.

Fig. 2: The explosive charge was placed at the base of the chimney

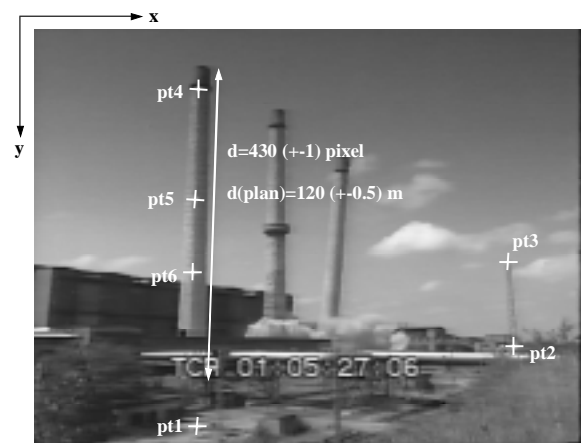
Figure 4 shows the three points tracked on the chimney (pt4-pt6), the three tracked fix points (pt1-pt3) and the information used to establish the pixel-to-meter transformation. For the measurements in the image space, 1 pixel corresponded to 0.28 meters in the object space with a precision of 0.5 meters.

Fig. 4: Sequence 1, pt1-pt3 tracked fix points, pt4-pt6 points tracked on the chimney

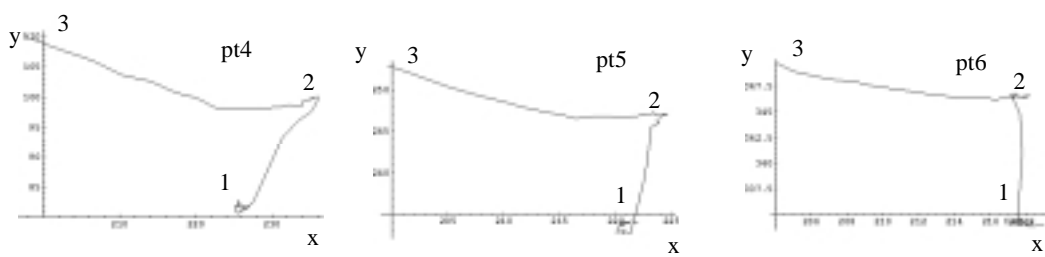
In figure 5, the trajectories of the three tracked points on the chimney are shown in the transformed coordinate system (fix camera system). The graph plots show clearly that the third chimney first fell vertically and at the same time a little to the right (1-2), stayed in balance for some time (2) and then fell to the wrong direction (2-3).

Fig. 5: Transformed pixel coordinates of the 3 points tracked on the chimney

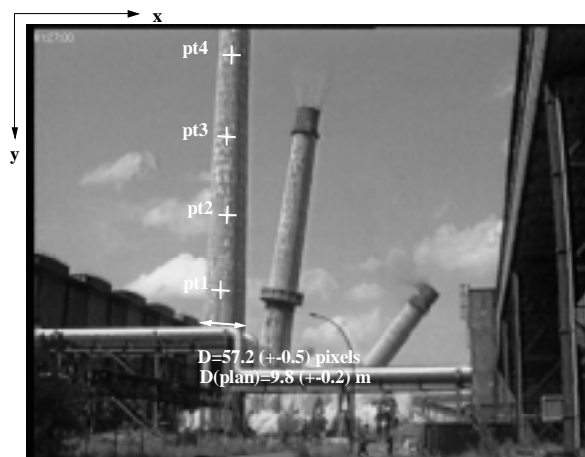
Fig. 6: Sequence 3, pt1-pt4 points tracked on the chimney

This sequence was used as primary source to extract the metric information because the quality of the images was higher and the view of the third chimney closer. A higher accuracy of the measurements could therefore be achieved. However, the side view of the chimney limited the extraction of information to the vertical dropping. After the analysis of the tracking process, it could be determined that the third chimney dropped vertically $3.4 (\pm 0.2)$ meters.

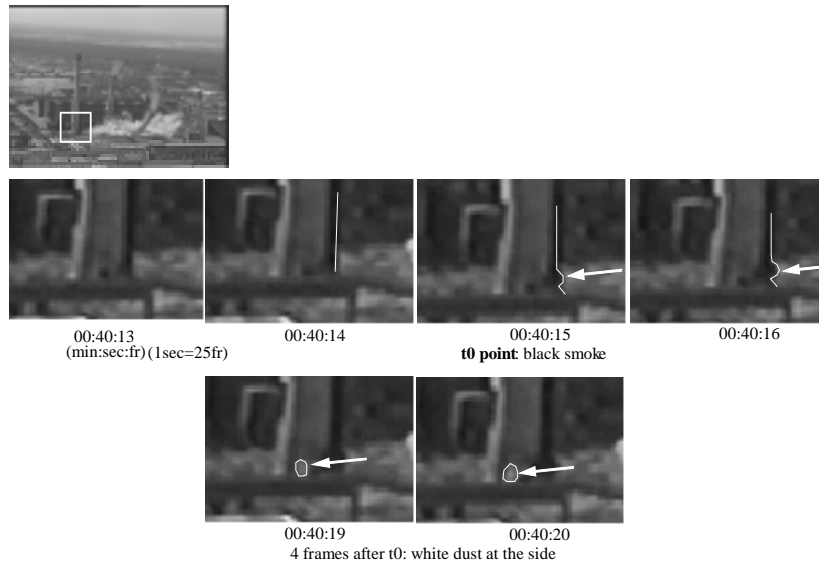
In order to clarify how long was the time interval between the detonation and the falling of the third chimney, we used the second and third sequences. Analyzing the single frames, it was possible to establish the exact moment (with 1/25 seconds precision) when the charge was lighted (t_0 point). In the figure 7, this moment can be clearly recognized as black smoke appearing at the side of the base.

On the following frame, an interesting event could be observed: white dust appeared at the lateral side of the base of the chimney. This fact was also an element to prove the presumption that the base was completely removed by the overpressure generated by the explosion.

Fig. 7: Charge lightning time (t0 point) and white dust at the side of the base of the chimney
