Extraction of Metric Information from Video Sequences of an Unsuccessfully Controlled Chimneys Demolition

Spremberg Germany, 10th July 1999: in the power plant Schwarze Pumpe, three old chimneys are going to be blown up. The first two fell in the prevented directions; the third ones had to fall onto the other two, but something went wrong and it fell onto the nearby building damaging it extremely.

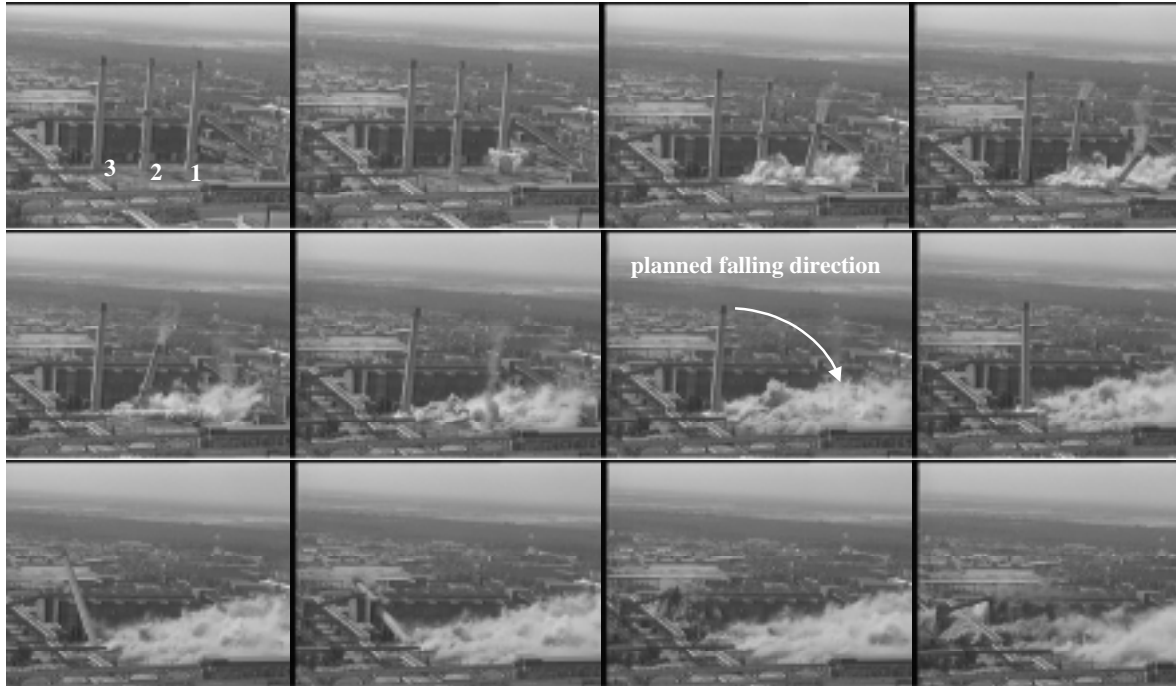
During the demolition of three old chimneys on the area of the power plant Schwarze Pumpe on the 10th of July 1999 one of the chimneys fell in a wrong direction causing damages on the surrounding buildings (see figure 1).

Fig. 1: Unsuccessfully controlled chimney demolition, Spremberg Germany, 10th July 1999; the third chimney was planned to fall to the right direction, but fell instead over the building.

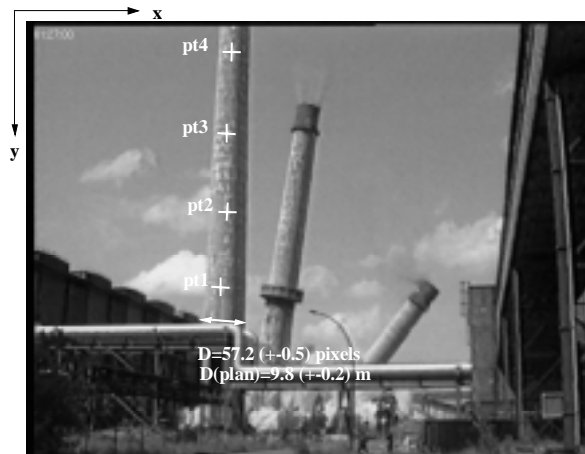
Fig. 6: Sequence 3, pt1-pt4 points tracked on the chimney

This sequence was used as primary source to extract the metric information because the quality of the images was higher and the view of the third chimney closer. A higher accuracy of the measurements could therefore be achieved. However, the side view of the chimney limited the extraction of information to the vertical dropping. After the analysis of the tracking process, it could be determined that the third chimney dropped vertically $3.4 (\pm 0.2)$ meters.
