Extraction of Metric Information from Video Sequences of an Unsuccessfully Controlled Chimneys Demolition

Spremberg Germany, 10th July 1999: in the power plant Schwarze Pumpe, three old chimneys are going to be blown up. The first two fell in the prevented directions; the third ones had to fall onto the other two, but something went wrong and it fell onto the nearby building damaging it extremely.

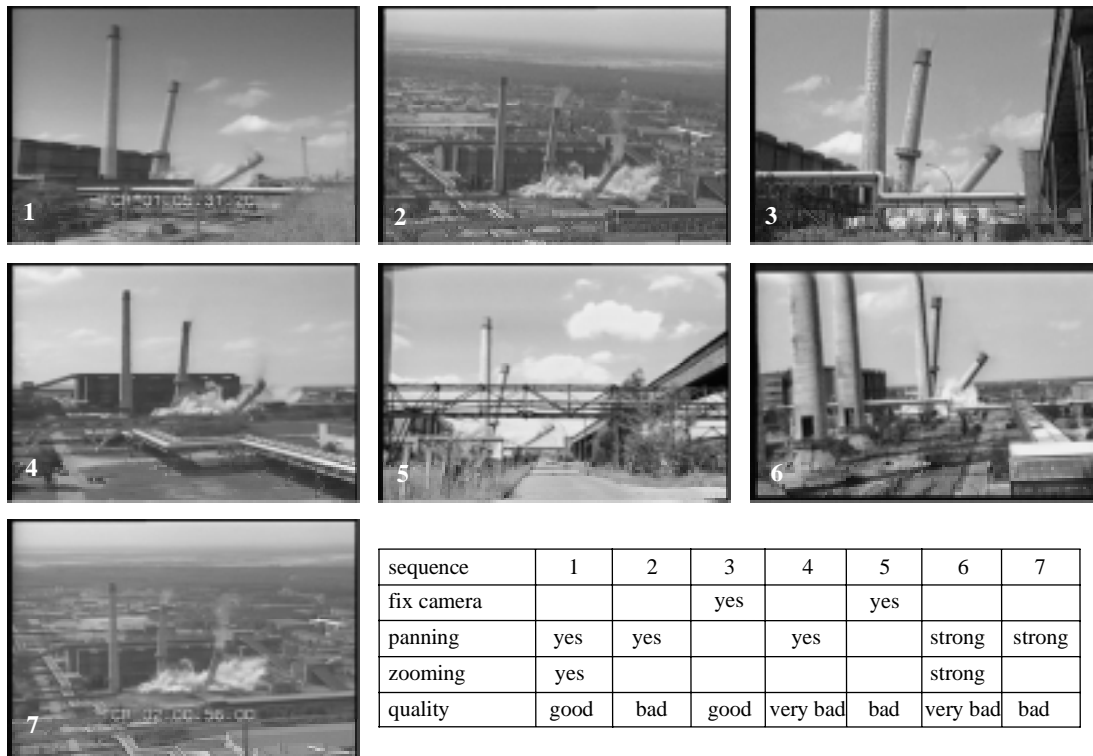
As can be seen in figure 3, the 7 video sequences were acquired from different positions and had different characteristics (table of figure 3). Only two sequences (seq. 3 and 5) have a fix camera, which simplifies the extraction of metric information. In the other sequences, where the camera moves, we have two cases: sequences where the camera has only a pan movement and sequences where the camera is also performing zooming. Two sequences (seq. 6 and 7) present so large movements that no reliable metric information can be extracted.

The quality of the videos has to be considered too. The sequences were indeed recorded on analog VHS tape as 2nd, 3rd or even more copies, therefore the quality was in general very low and in two cases (seq. 4 and 6) it was too bad to extract metric information. After the analysis of the video sequences, we concluded that only the first three sequences were useful for our purposes.

Fig. 3: Shots of the 7 video sequences and their characteristics (table)
